June 1996

Weller Creek Streambank Stabilization Report

Village of
Mount Prospect

Rust Environment
& Infrastructure

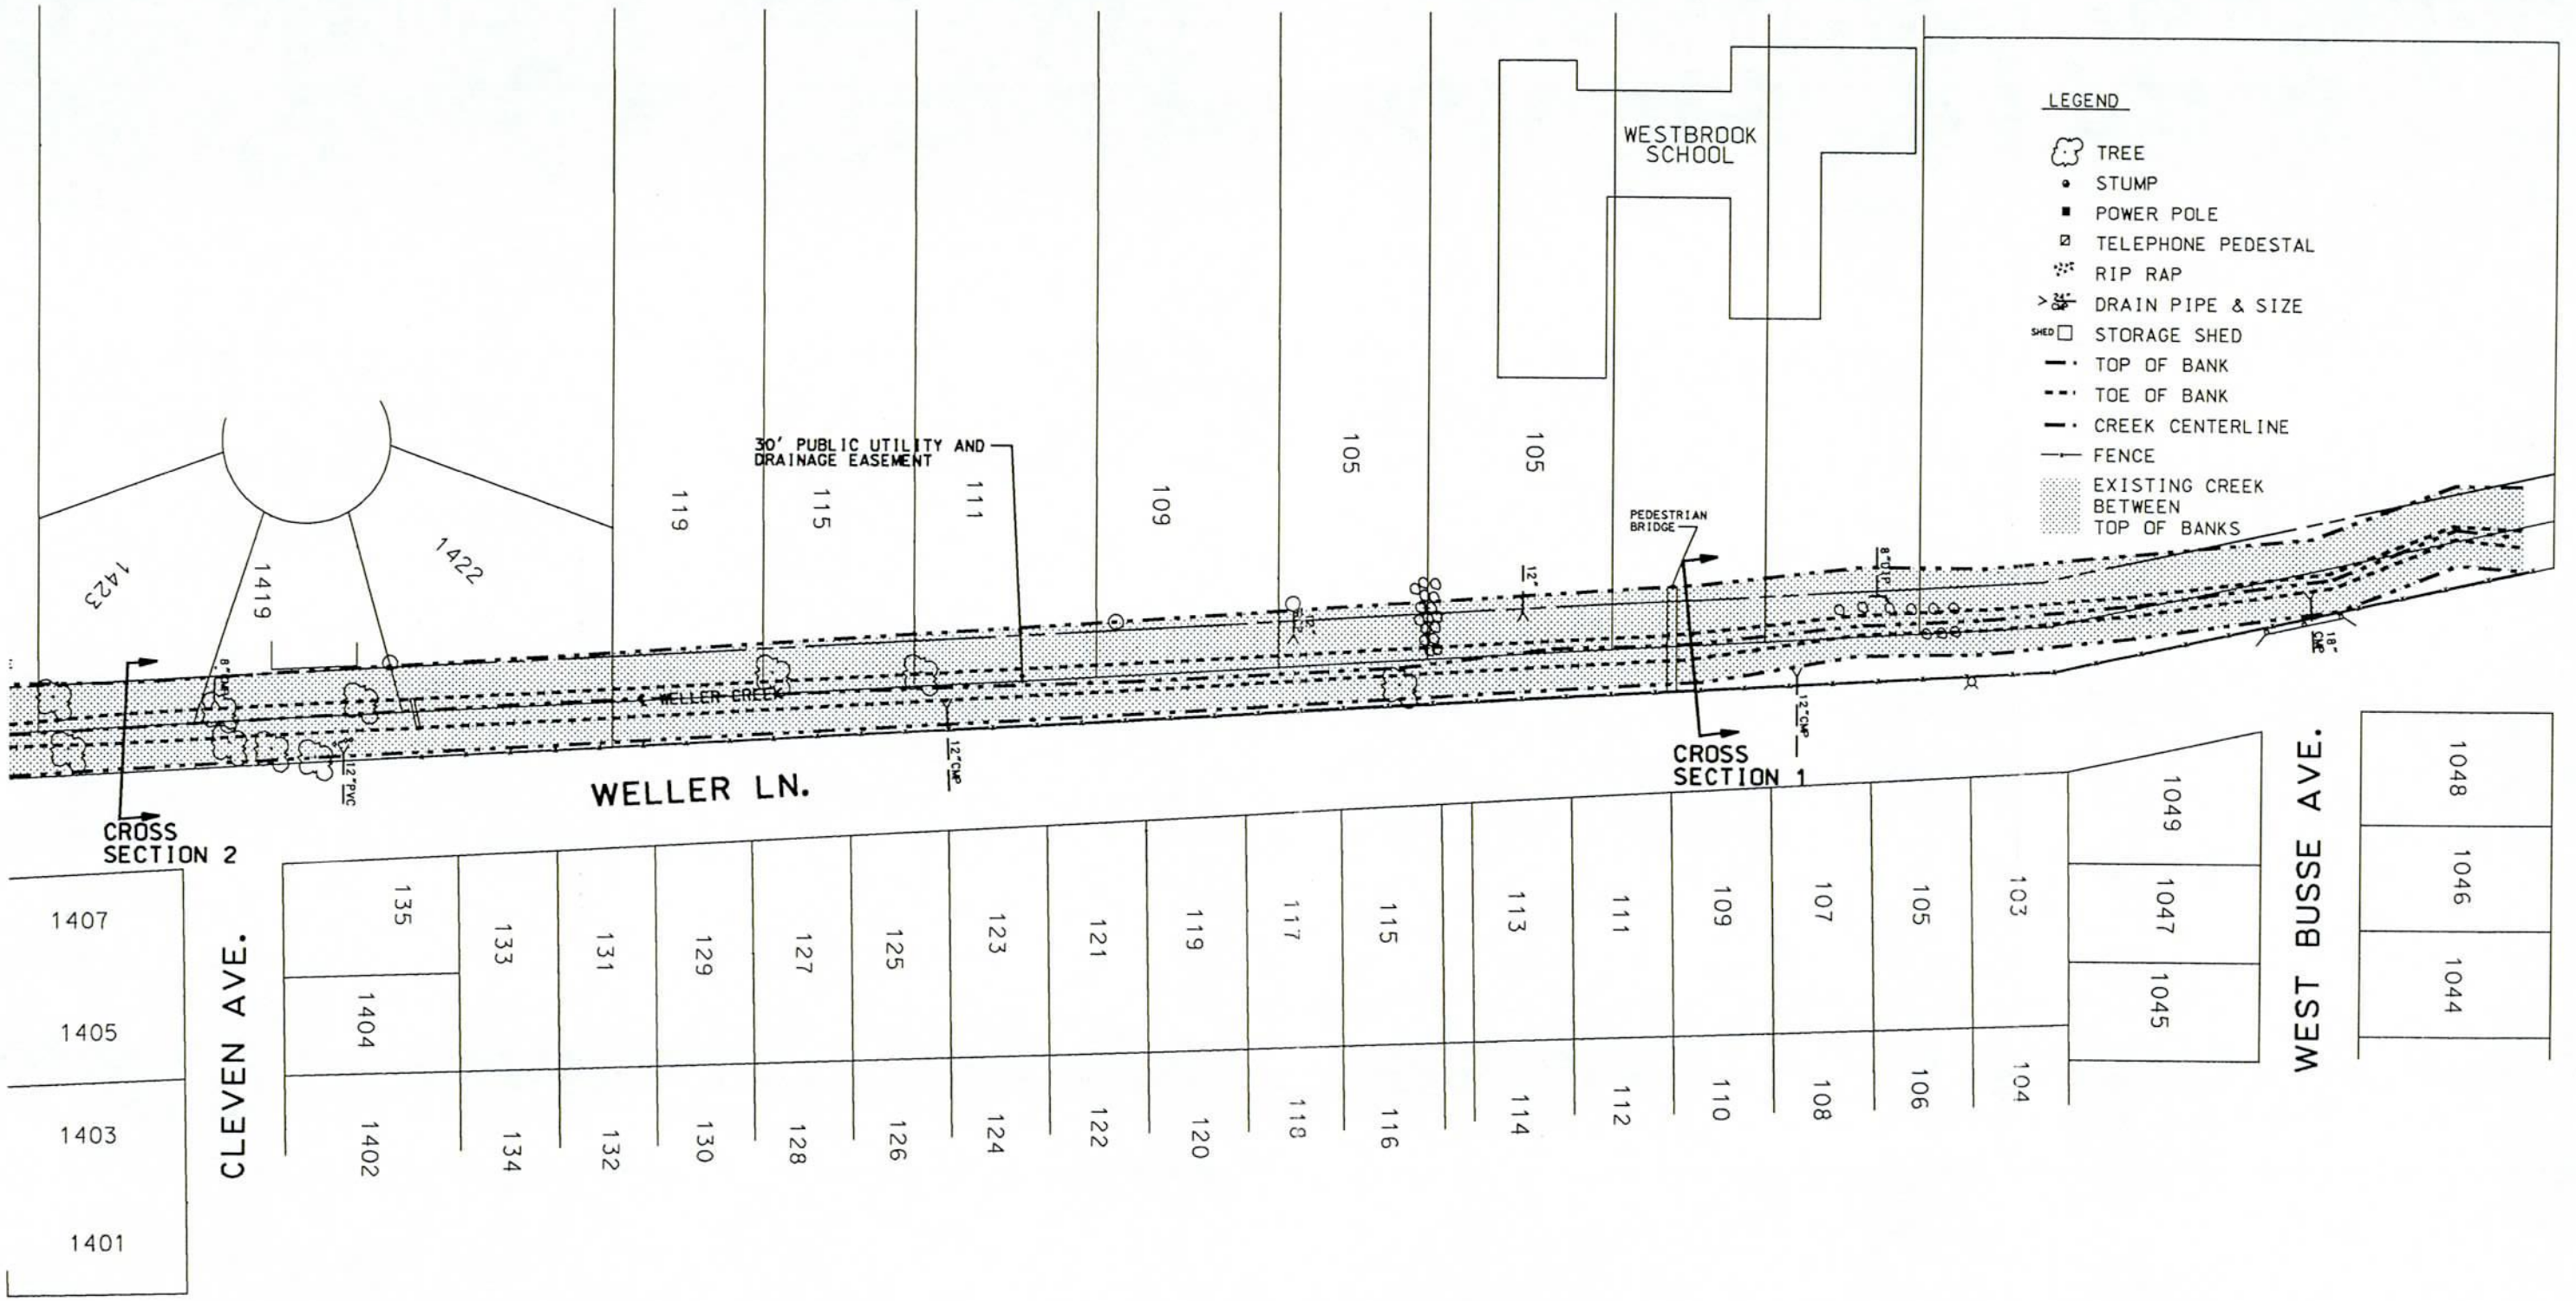
FIGURE C-1D

Reach D exhibits moderate erosion. The bioengineering treatments recommended for this reach are A-jacks, lunkers or coir fiber rolls into the existing void created at the normal water line. Live plant plugs and dormant or rooted cuttings are incorporated into these techniques. Any localized erosion areas immediately upslope of this treatment would be covered with a permanent erosion control blanket and planted or seeded.

Reach D has sewer outfalls which create large areas of local erosion. Drop structures are recommended for each of these locations to discharge stormwater at or near the normal water elevation. Protection should be provided on the bank opposing these structures. Backfilling of areas excavated for drop structures should be accomplished utilizing vegetated geogrids.

EXISTING CONDITIONS REACH D - WEST CENTRAL TO CLEVEN
WELLER CREEK STREAMBANK STABILIZATION

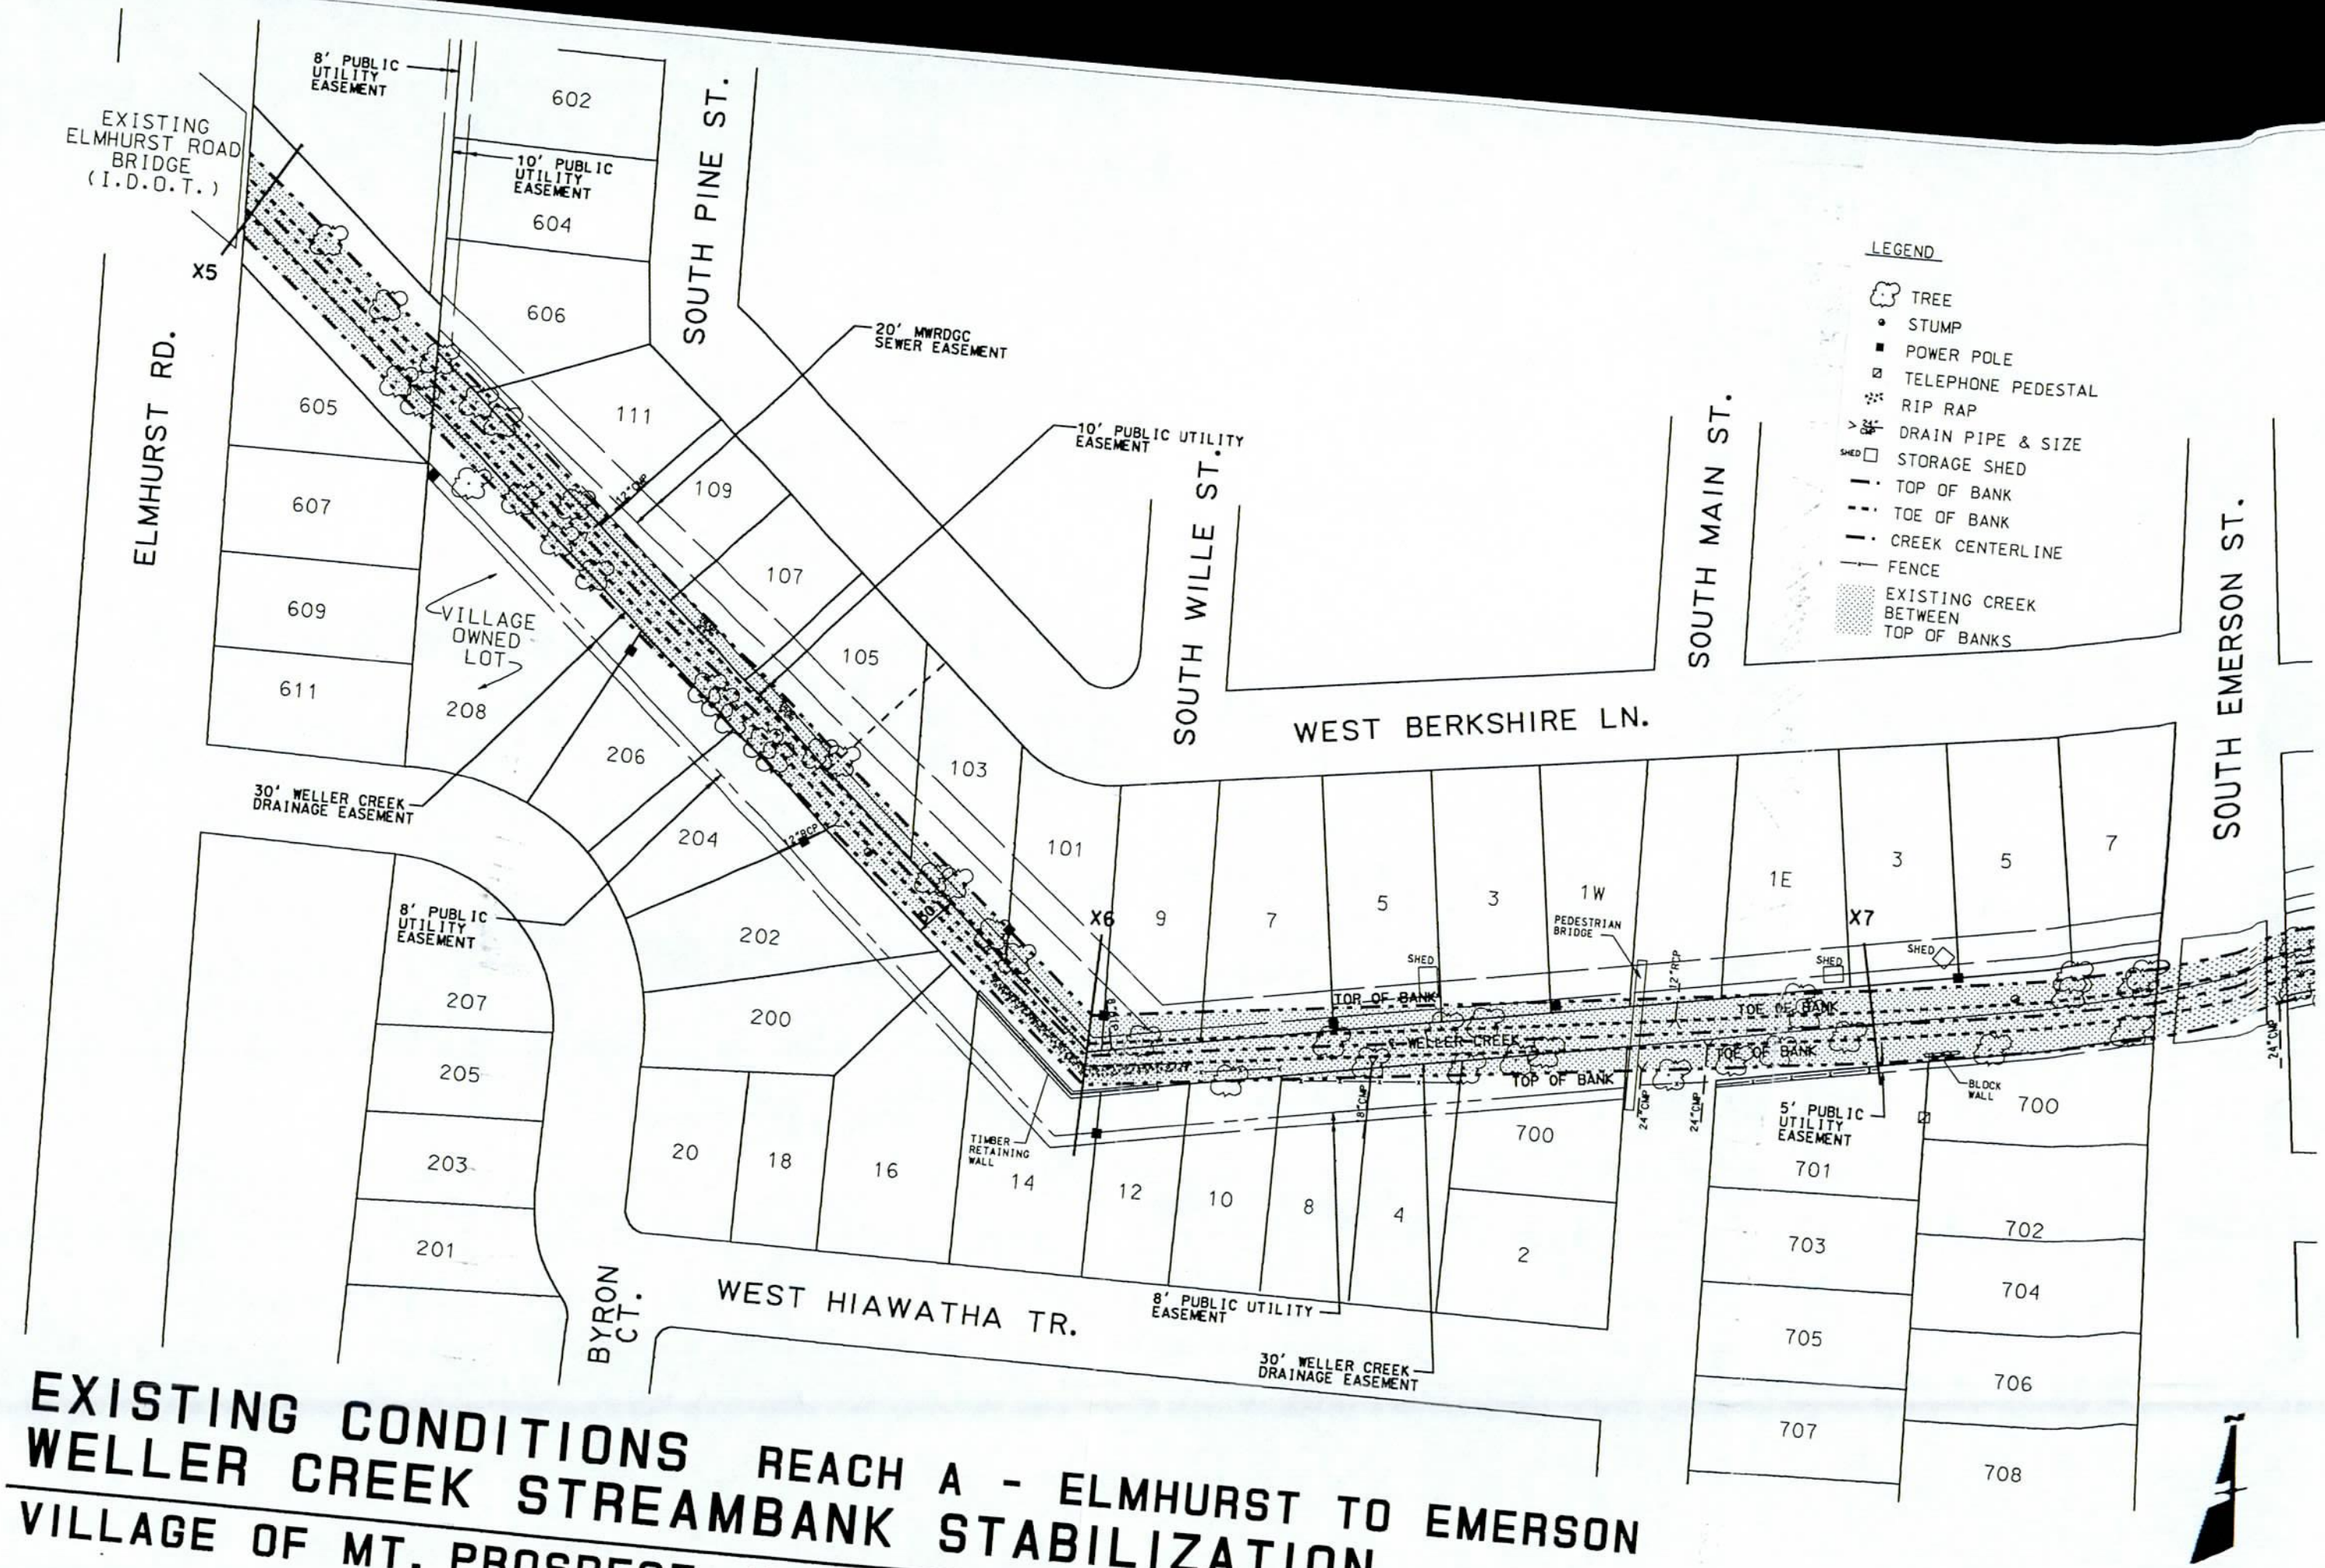
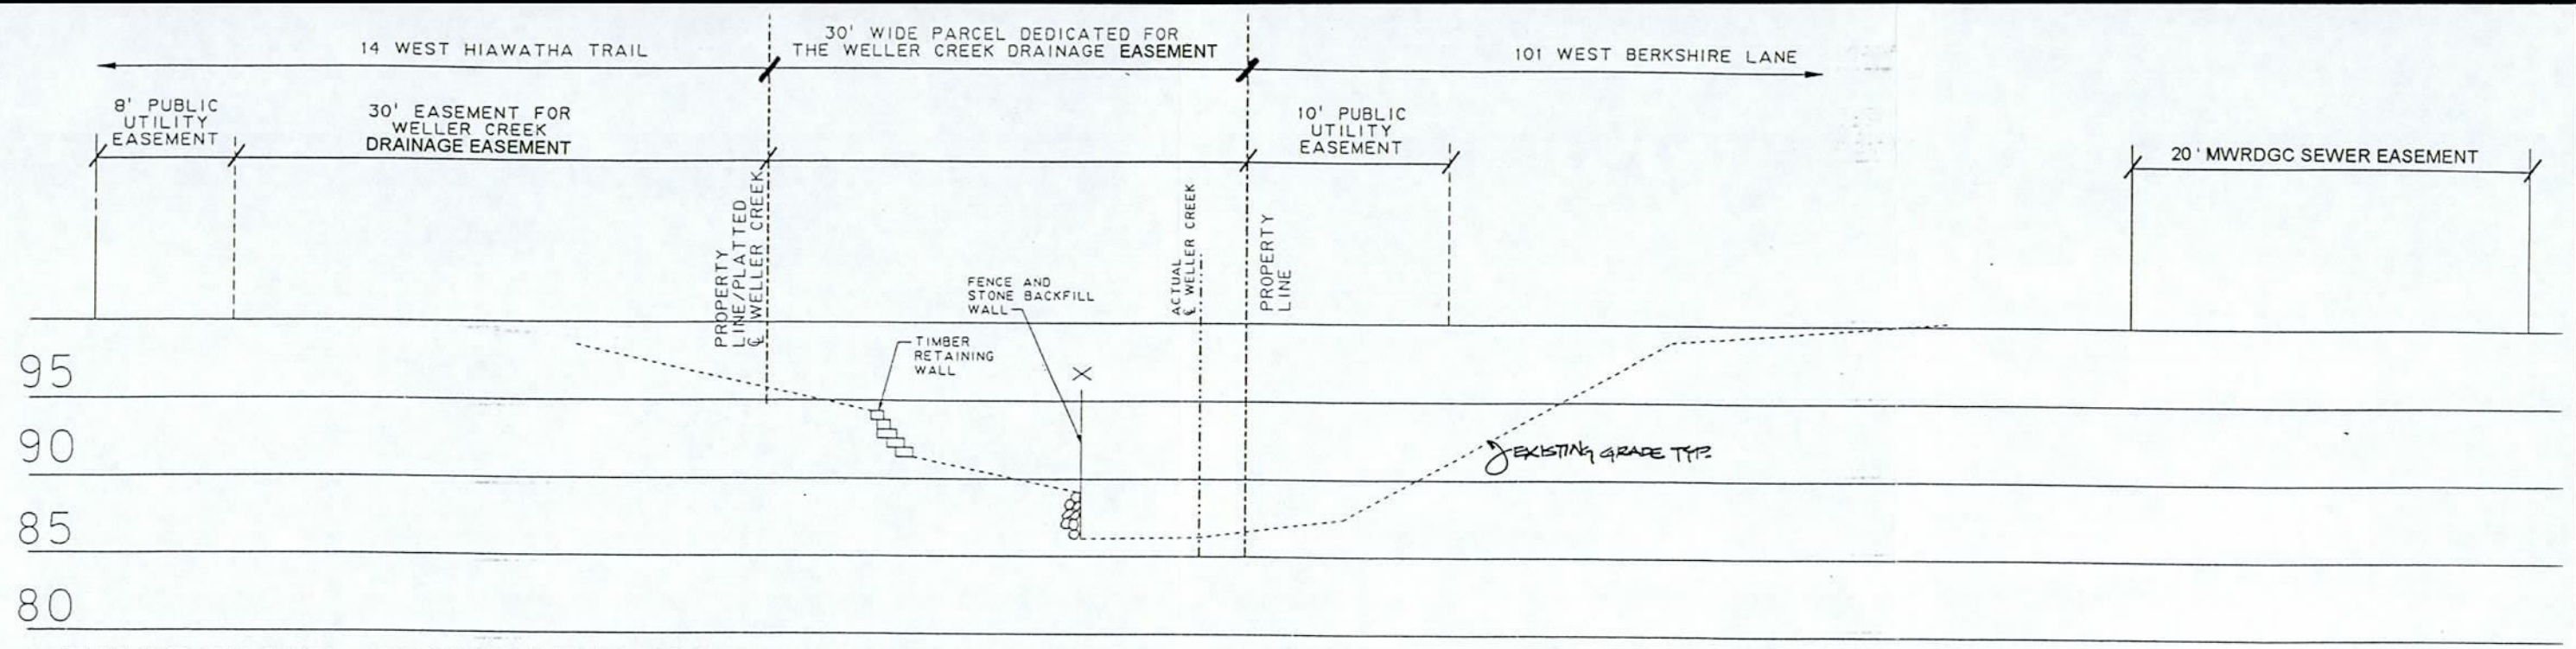
Reach A has the severest erosion on the south bank from Emerson Street to one lot past Main Street. The structures on these three lots are significantly closer to the creek than the surrounding lots. Main Street dead ends at this location with the pavement ending at the top of the slope. Surface runoff from the pavement and associated storm sewers add to the erosion problem. In addition, foundations for the pedestrian bridge at Main Street are undermined.

EXISTING CONDITIONS REACH A - ELMHURST TO EMERSON
WELLER CREEK STREAMBANK STABILIZATION
VILLAGE OF MT. PROSPECT, ILLINOIS

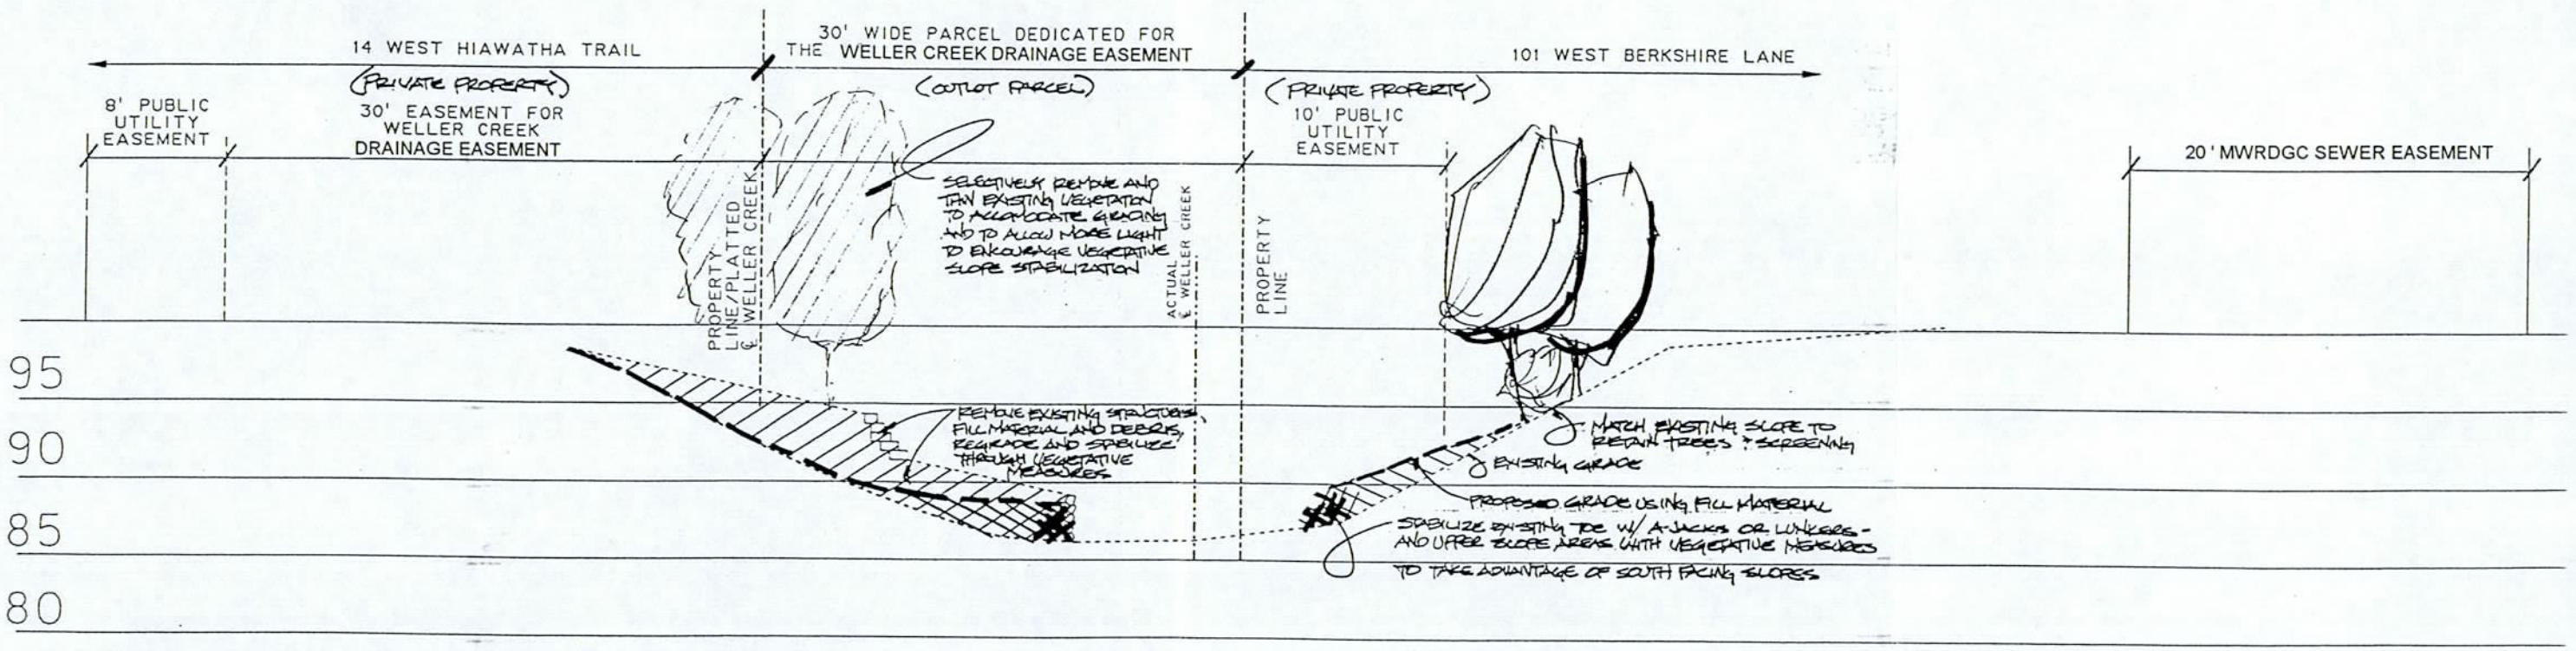
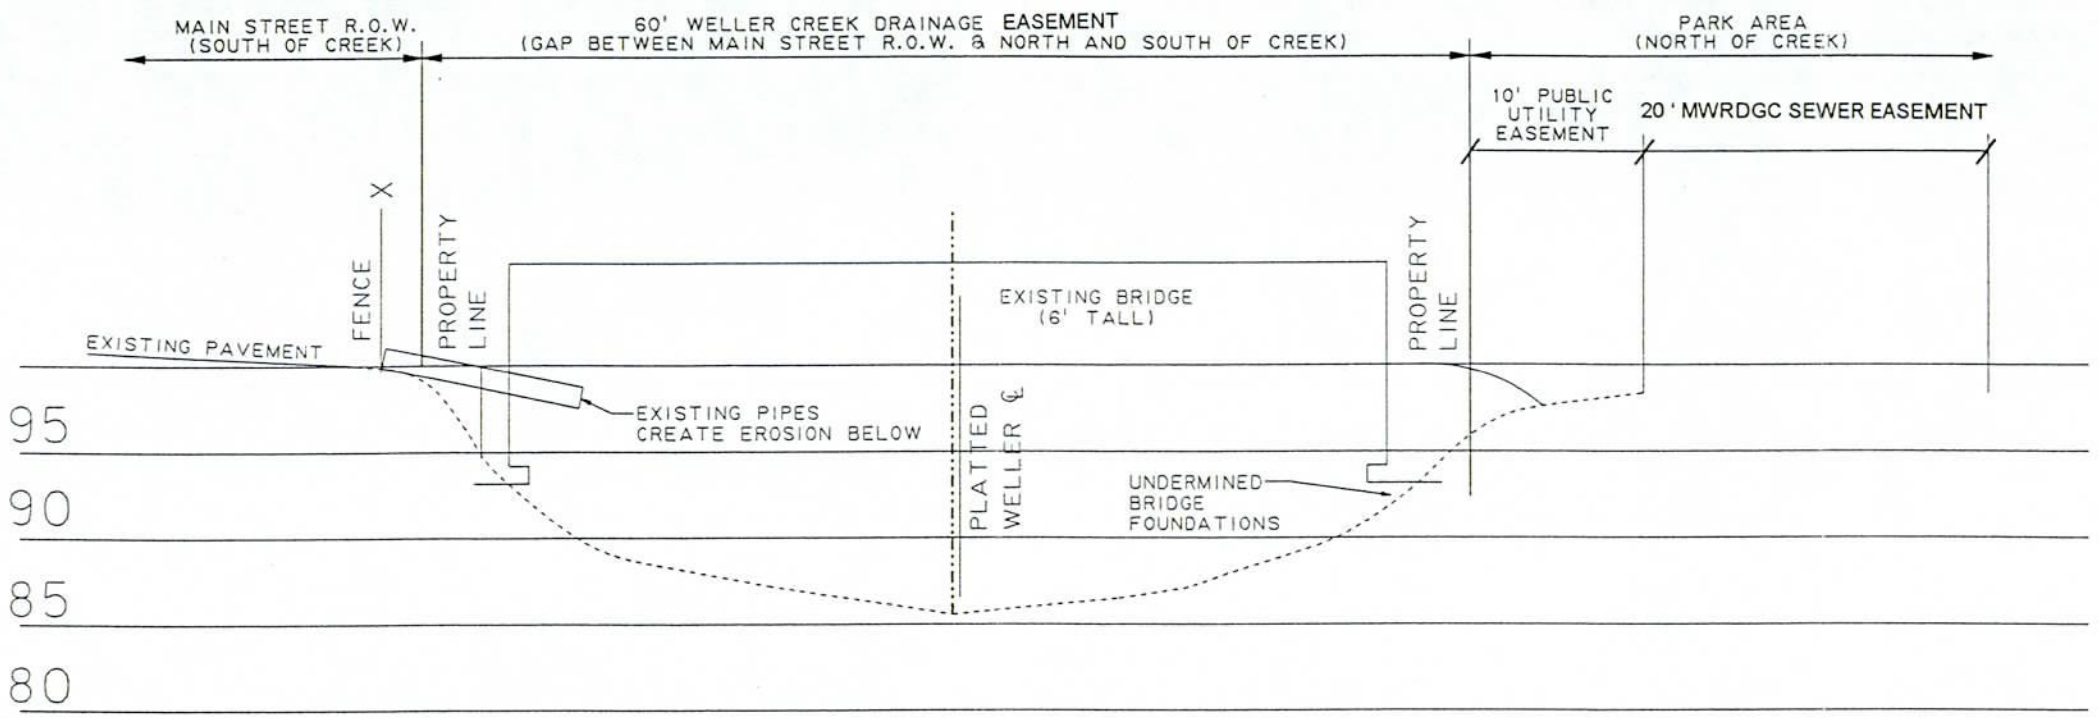
VILLAGE OF MT. PROSPECT, ILLINOIS **FIGURE C-2A**

EXISTING CONDITIONS
CROSS SECTION LOCATION 6

PROPOSED CONDITIONS
CROSS SECTION LOCATION 6

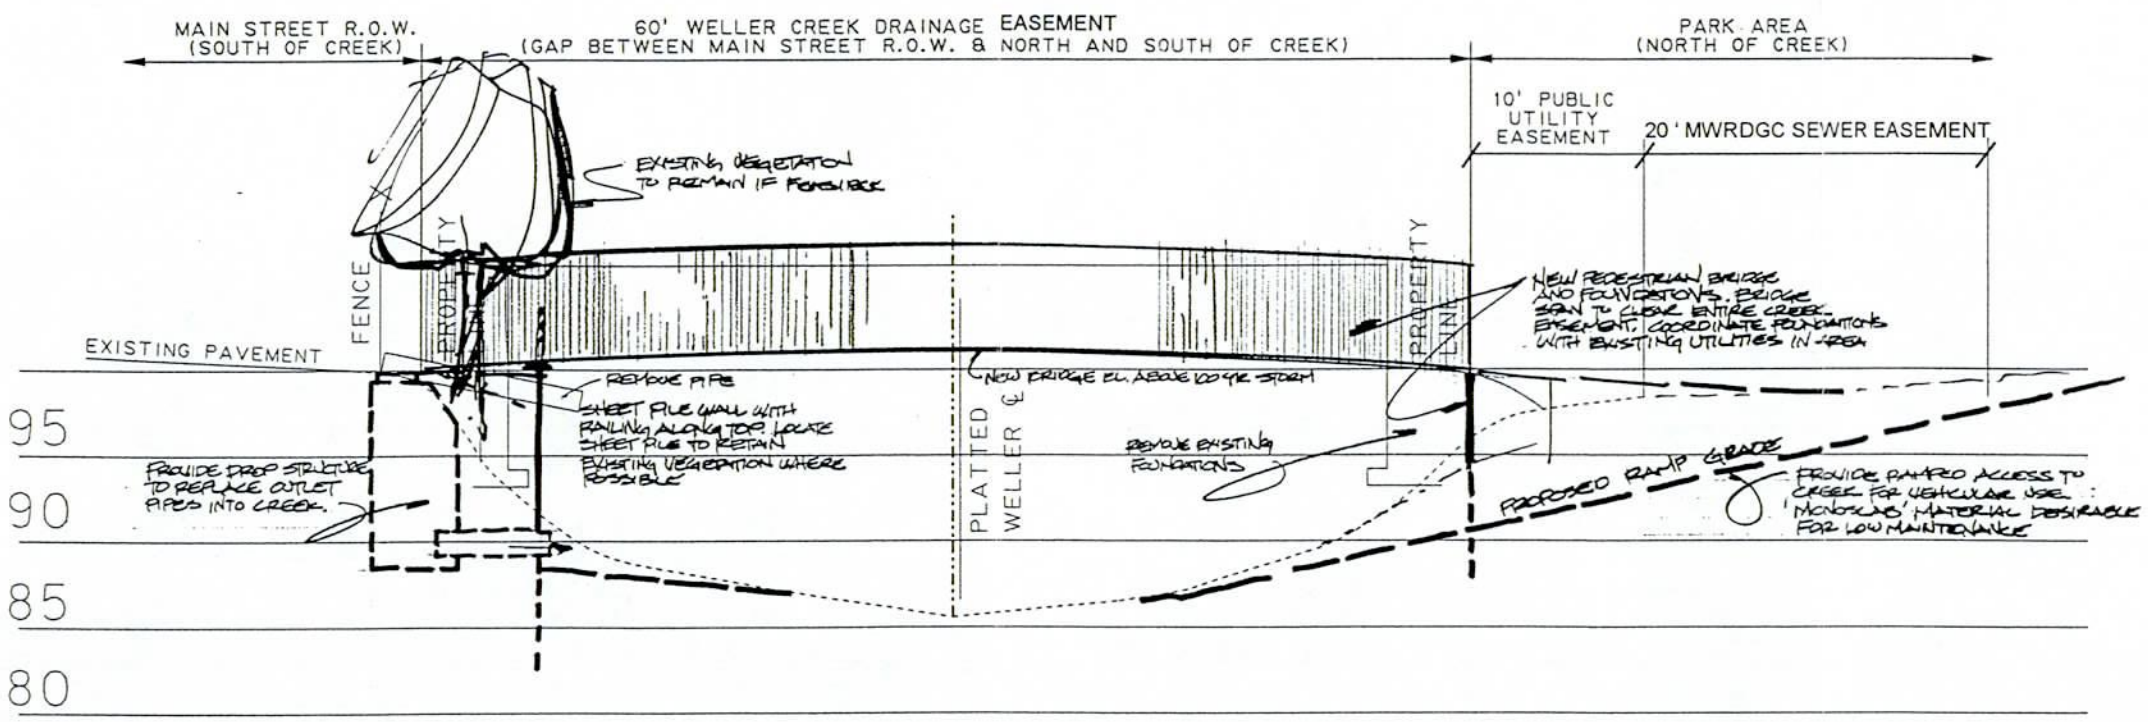
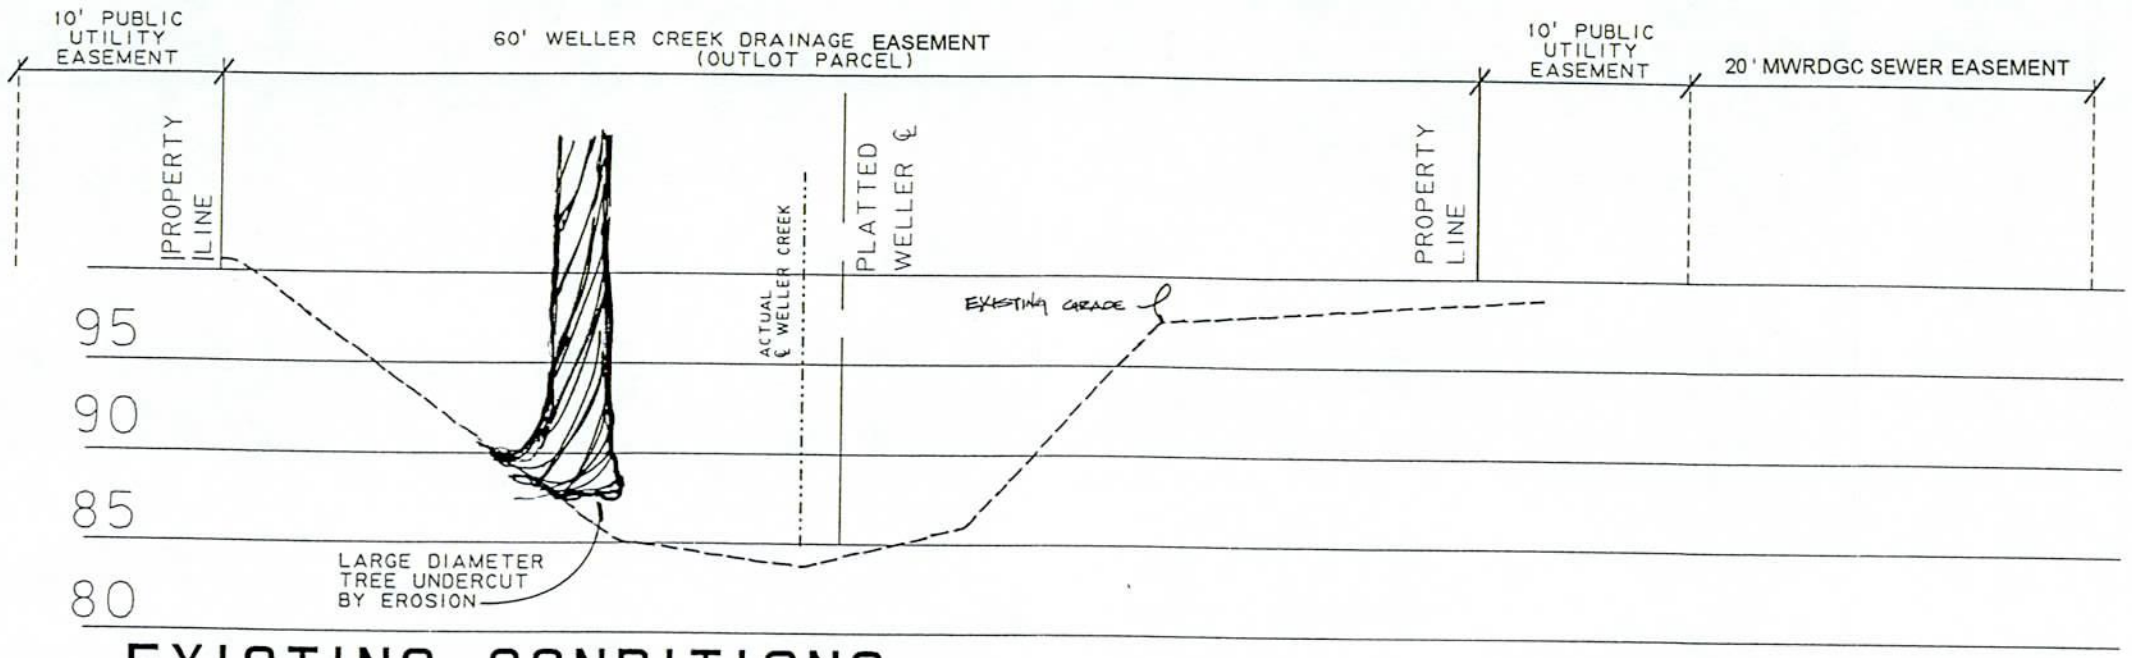
VILLAGE OF MT. PROSPECT, ILLINOIS **FIGURE C-2B**

EXISTING CONDITIONS
CROSS SECTION AT MAIN STREET R.O.W.

PROPOSED CONDITIONS
CROSS SECTION AT MAIN STREET R.O.W.

Replacement of the existing Main Street pedestrian bridge and Emerson Street bridge is also desired. The sheet piling or retaining wall solution to the erosion can act as a footing or base for placement of a new pedestrian bridge. The Emerson Street bridge should be reconstructed above the 100-year water surface elevation (656.8 feet National Geodetic Vertical Datum) to keep it passable during large storms.

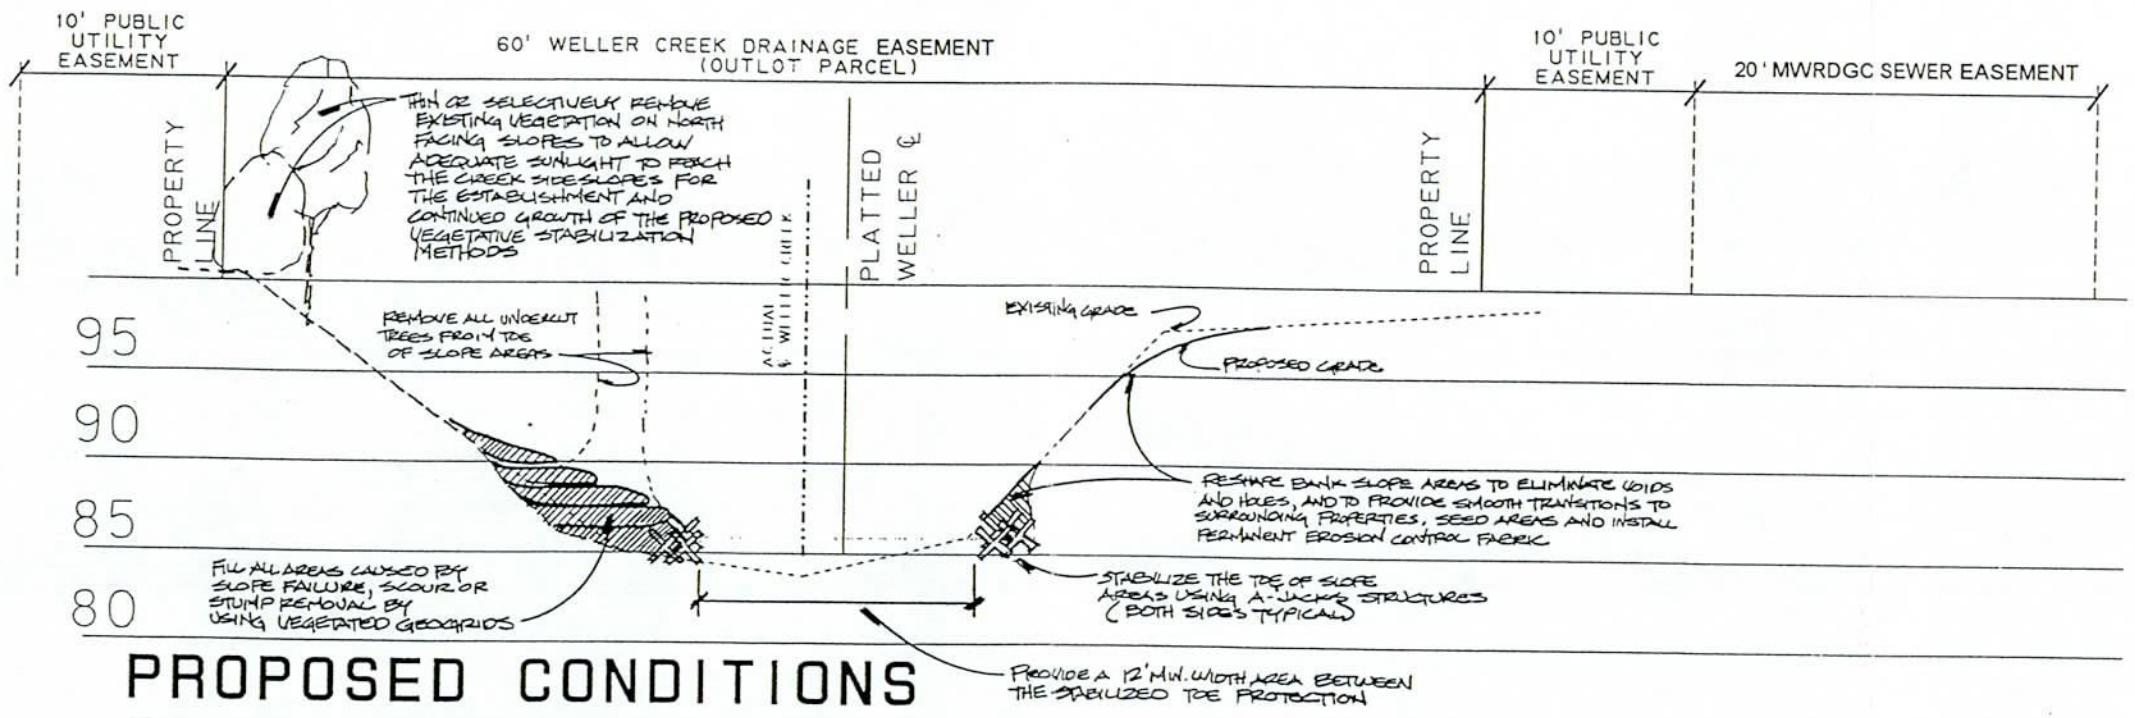
VILLAGE OF MT. PROSPECT, ILLINOIS **FIGURE C-2C**

EXISTING CONDITIONS
CROSS SECTION LOCATION 9

PROPOSED CONDITIONS
CROSS SECTION LOCATION 9
